DOCUMENTATION OF THE CIVIL WAR VESSELS CSS FLORIDA AND USS CUMBERLAND HAMPTON ROADS, VIRGINIA DEPARTMENT OF DEFENSE RESOURCE MANAGEMENT PROGRAM, DEMONSTRATION PROJECT NO. 348

PANAMERICAN CONSULTANTS, INC.

FINAL REPORT

MAY 1994

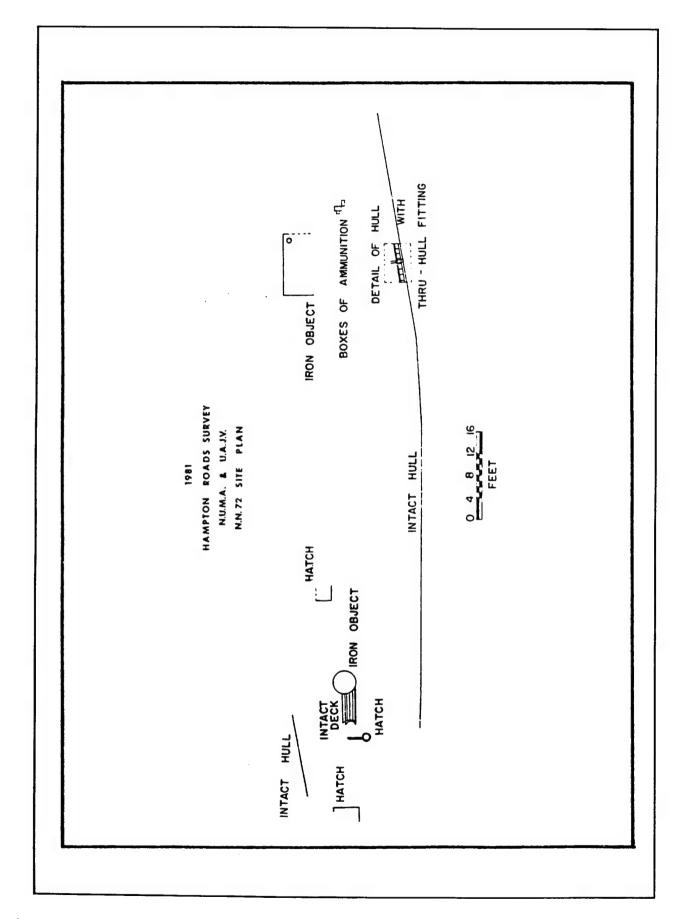
Figure 21. 1981 Florida Site Plan (As Presented in Underwater Archaeological Joint Ventures 1982).

Located off the Horne Brother's shipyard, the intact remains of the *Florida* were found to be in excess of 135 feet with scattered hull debris continuing both fore and aft. Illustrated in Figure 21, the wreck was composed primarily of the lower hull, which rested on an even keel. Features observed and recorded on the Horne Brothers site included:

a 121 foot section of hull on the inshore side composed of 6.5 x 7 inch frames, 3 inch ceiling and 5 inch outer planking; a 16 foot section of hull on the offshore side; a small scuttle in the deck with a 13 inch inner diameter; a large iron object 11 feet x 5 feet 6 inches consisting of two adjacent cylinders which may be boilers; and directly inshore of this, a copper alloy through fitting 4.5 inches inner diameter, possibly an intake valve for the boilers. Among the other observed and recorded features are 2 hatchways, 2 feet 8 inches and 5 feet wide, for and aft respectively of a massive, flat, circular iron object 4 feet 3 inches in diameter (Underwater Archaeological Joint Ventures 1982).

As stated in their report, one factor which contributed significantly to their ability to gather information from the site was the fact that there was very little sedimentary overburden in most areas examined, with the exception of the largely buried upriver end (Underwater Archaeological Joint Ventures 1982).

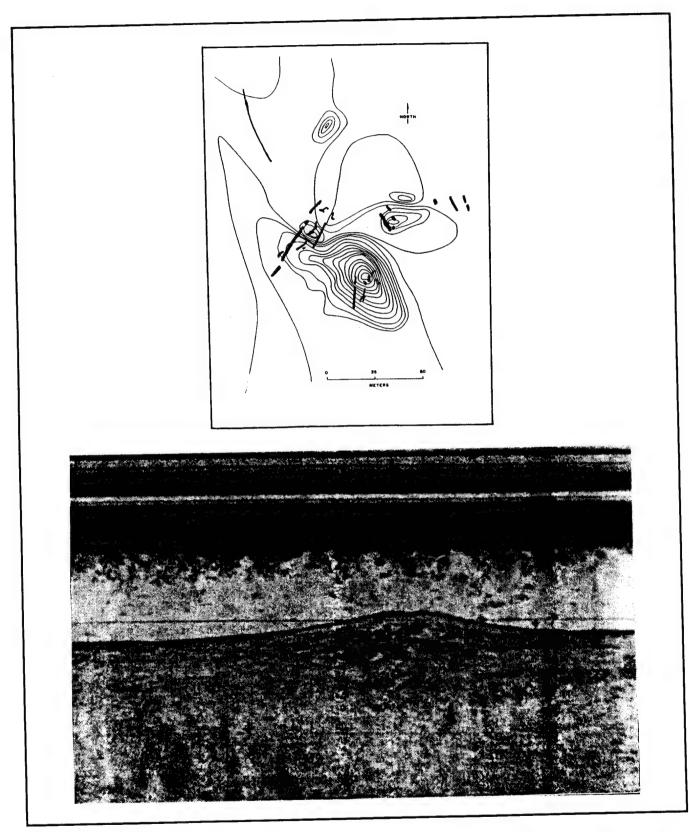
Figure 22. Cumberland site sonargram and magnetic contour map (As presented in Watts 1987).

In 1986, Tidewater Atlantic Research (TAR) was contracted to conduct a magnetic and acoustic remote sensing survey of the remains of the Cumberland and the Florida. Illustrated in Figures 22 and 23, remote sensing data characterizations of the Florida and Cumberland indicated that the Florida had a high degree of structural preservation and the Cumberland remains appeared disarticualted (Watts 1987). On the basis of Watts report, a mapping project employing a Sonic High Accuracy Ranging and Positioning System (SHARPS) was conducted on the Cumberland by the HRNM and MOBDIVSALU TWO. Although working only sporadically during the 19-day investigation, enough data was collected to produce a preliminary site map. Illustrated in Figure 24, the SHARPS map shows a concentrated but disarticulated assemblage of vessel components and artifacts (Hampton Roads Naval Museum 1987).

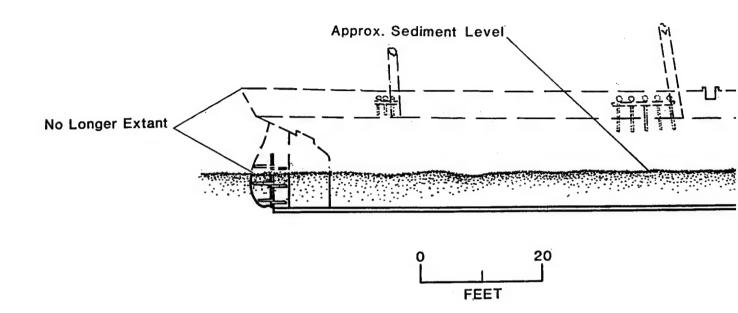
24. An iron box, 4 feet by 2.5 feet and protruding 2 feet from the bottom sediment, with iron straps or bands on its upper edge and corners, was located. Without a top and empty of contents, it may represent one of two boxes with similar characteristics located during the 1983 survey (Hampton Roads Naval Museum 1987:8). Numerous disarticulated timbers and metal fragments from the vessel, as well as intrusive items such as pilings, and wire rope were observed throughout the investigated area.

Situated approximately 10 feet from the iron box was a run of frames and some planking covered by marine life in the form of weed, gorgonias, and crabs. This section measured at least 10 feet in length and protruded from the bottom 5 feet. The section was composed of some unknown type of machinery with large frame timbers, some nearly 12 inches square. Four-inch-thick planks were visible in the sediment at the base of the wreckage. The upper surfaces of the timbers on this section are eroded, but some wood, especially the large timbers, have smooth well-preserved surfaces. This section of wreckage is semi-articulated and is indistinguishable as to component type or hull area (e.g., outer hull, inner stanchions, etc.). However, only iron fasteners were observed, and their presence and the lack of copper alloy fasteners indicates that this is an internal or above water-line vessel component.

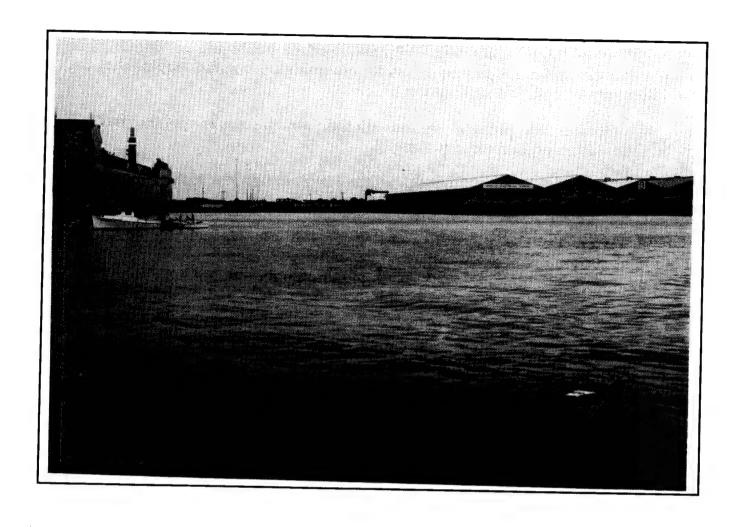
Figure 32. Photograph showing clamming activies adjacent to the Florida wreck site. Site buoy is in the foreground.

If elected, data recovery at the wreck of the *Florida* should be conducted in accordance with a detailed data recovery plan. As the plans that exist for the *Florida* were only recently produced from the builders' model, research should attempt to
